Inspection reference: Sample

Confidential Inspection Report
123 Main St.
Small Town WA

April 22, 2023

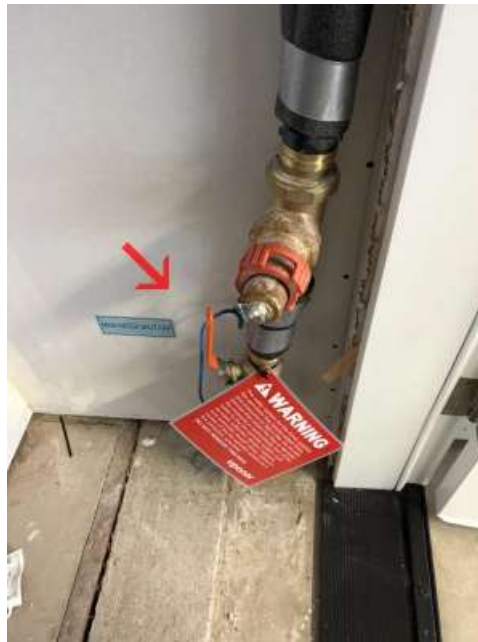
- 1.7 The domestic water supply main shutoff valve was near the Water Heater.

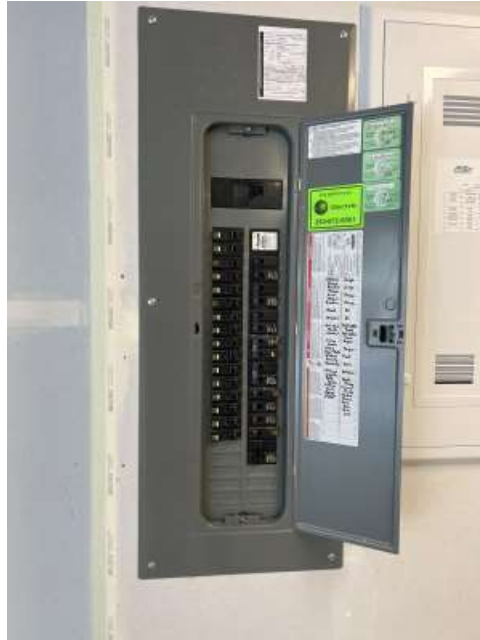
- 1.8 The main electrical distribution panel was located in the Garage.

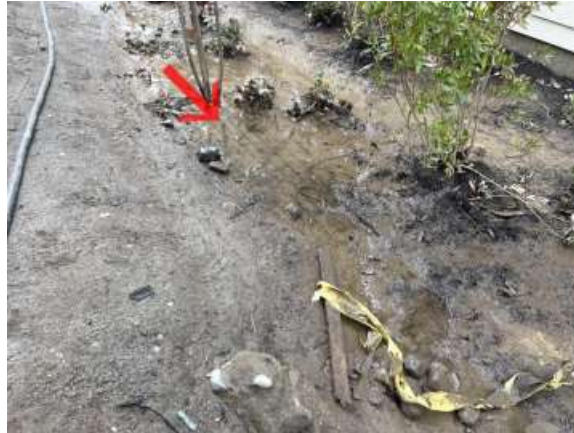
| 2.9 | The left side of the property was flooded over a large area. Any drain system that may be installed is inadequate or not installed.

<i>SUGGESTION:</i> We recommend sub-surface, french drains or a system to assist in eliminating water ponds on the property. |

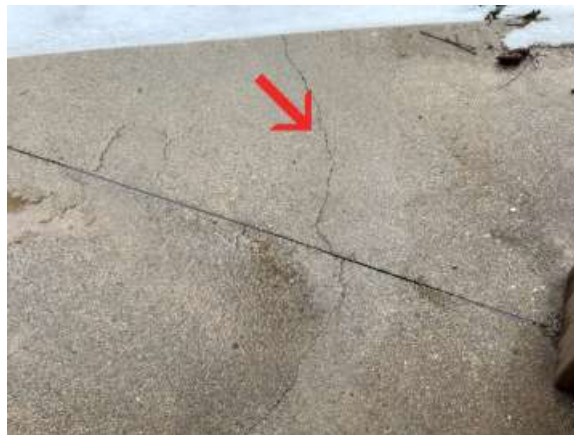
2.10 Condition

Moderate cracks were observed in the driveway surface. These cracks may indicate poor soil conditions, age/wear and/or inadequate original preparation for installation of the pavement.

SUGGESTION: The cracks may be sealed to temporarily extend the useful life of the driveway.

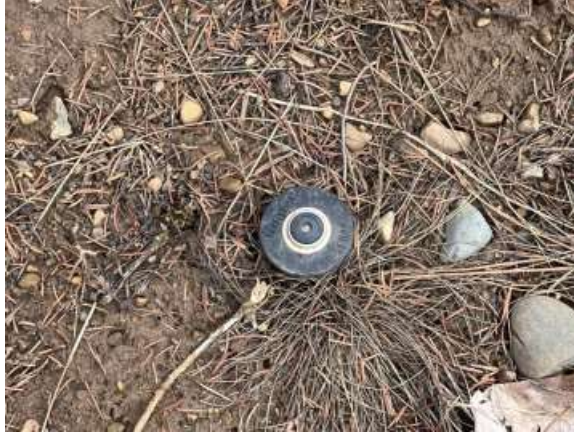
The site/grounds has an irrigation system installed. This system was not tested during our inspection, due to it being beyond the scope of our inspection.

SUGGESTION: We recommend consulting the homeowner or a irrigation specialist for a demonstration and inspection of this system. Any maintenance or repairs should be performed if warranted.

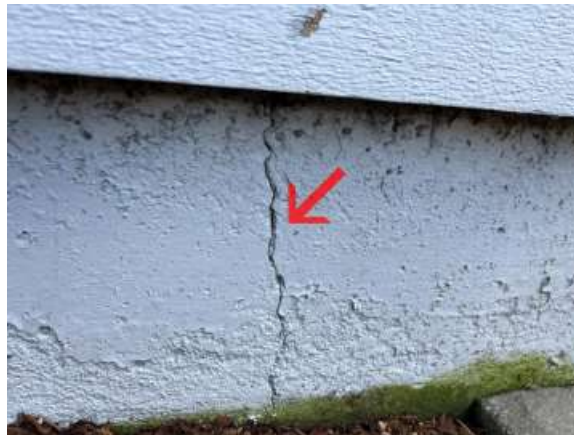
- 3.5 *Condition* Moderate sized cracks were observed on the Exterior foundation. This suggests unstable or settling soils.
SUGGESTION: We recommend a soil or structural engineer should be consulted for corrective repairs. This may include sealing the pieces back together with a concrete or similar patch. Sealing is to deny possible moisture entry.

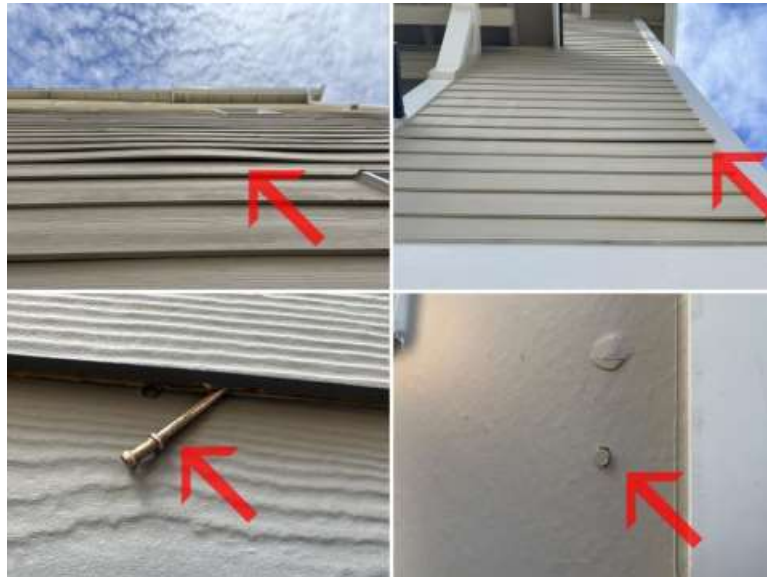
- 3.6 *Condition Damage*

Nails were sticking out of the siding material. This can cause accelerated deterioration of the siding from moisture.

Small sections of the siding have no space between the planks. This is causing buckling of the siding.

SUGGESTION: Secure all nails, caulking and painting of all nail heads, surface breaks and depressions that have broken through the siding surfaces is recommended.

SUGGESTION: We recommend repair by the contractor to industry standards. This was observed on the Several Sides.

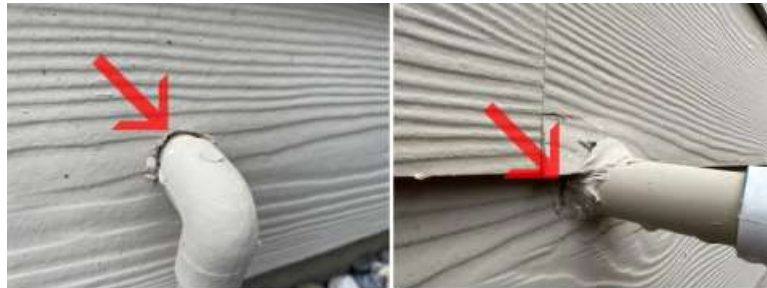
3.7 Penetrations and Caulking

Gaps and/or holes were observed on one or more sides in the siding, around the gas meter, wiring and/or around plumbing penetrations.

SUGGESTION: We advise that all the holes and the gaps be caulked and/or sealed to prevent moisture and/or pest intrusion.

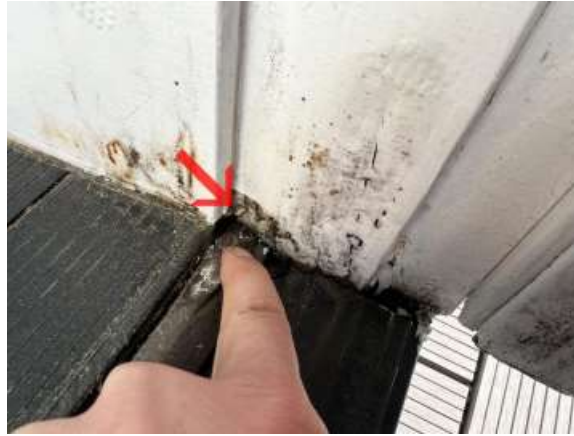
3.10 Damaged, Gaps and Frames

The Exterior door frame is damaged.
SUGGESTION: We recommend that it be repaired or replaced as needed. This was observed at the Rear Door.

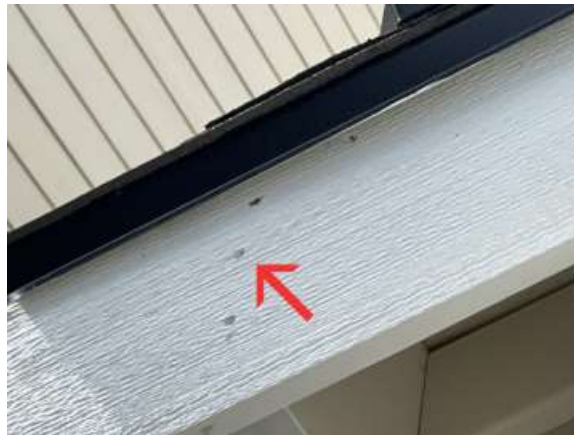
3.13 *Condition-Damaged Joints*

and A number of holes or deflections through the surface of the trim material were not properly caulked and sealed. These were caused by driving nails deep into the trim material. This can cause accelerated deterioration of the trim from moisture. **SUGGESTION:** Caulking and painting of all nail heads, surface breaks and depressions that have broken through the trim surfaces is recommended.

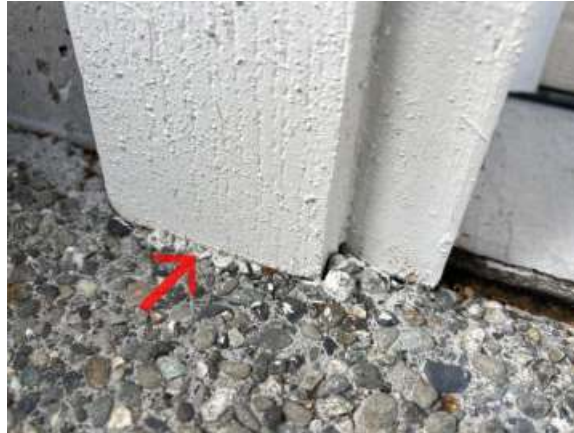
3.14 *Trim-Pillars, Concrete, Roof or Loose*

Portions of the trim are embedded in concrete surfaces. This is not an acceptable practice. Modification would be difficult, but this can allow moisture absorption and pest infestations.

This was observed at the Left Side.

SUGGESTION: We recommend as preventive maintenance the area be flooded with a wood preservative from time to time and that the open seam be caulked or sealed closed to help deny moisture entry.

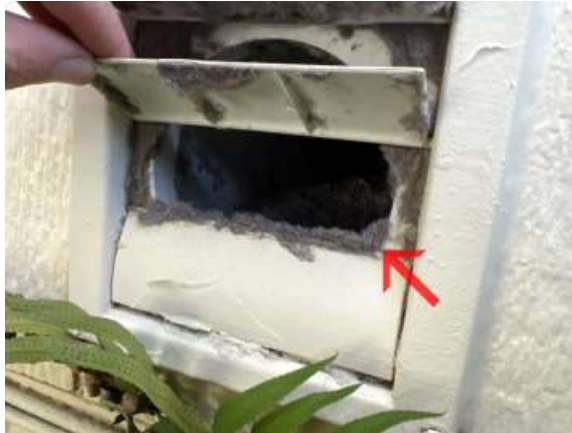
The clothes dryer vent damper had become clogged with lint, dirt or debris. This is a fire hazard and reduces efficiency.

SUGGESTION: Dryer ducts should be disassembled and cleaned on a regular basis.

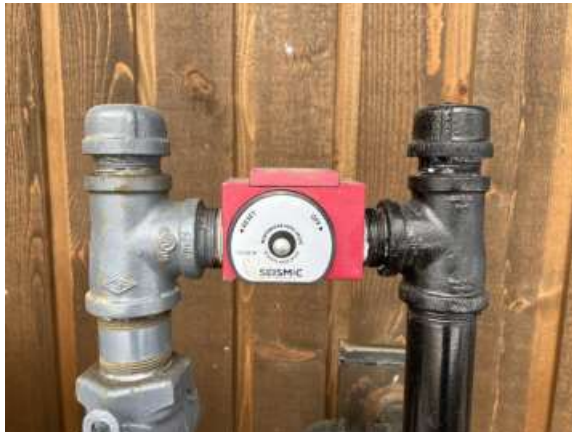
The gas piping was in acceptable condition where accessible. No evidence of leaks were detected at any of the exposed gas pipe. Pressure testing may reveal leaks, but this procedure would be considered beyond the scope of a home inspection.

A automatic gas shut off device has been installed on the main gas supply pipe adjacent to the gas meter, which is a beneficial upgrade in the event of an earthquake. This was not tested during our inspection and we suggest reviewing the operation directions.

We recommend that all exposed sections of gas piping be prepped and painted with a rust inhibitor coating to help prevent future deterioration or rusting of the pipes.

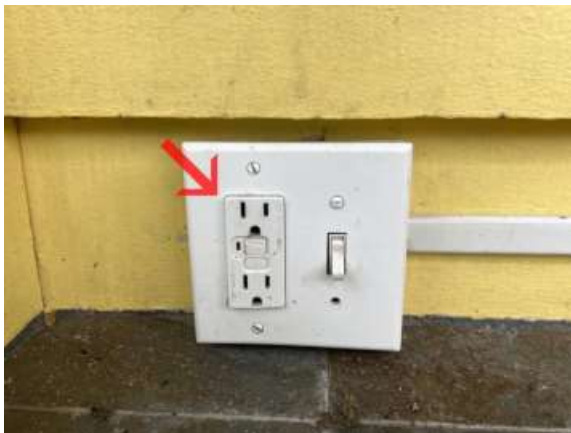
3.27 Receptacles

One or more of the Exterior receptacles were missing/damaged their moisture rated cover plates.

This condition was observed on the Rear Side.

SUGGESTION: Proper replacement is recommended.

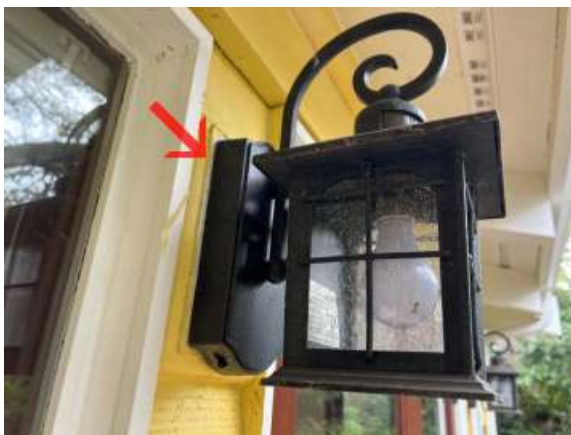
3.28 Light Fixtures

Exterior light fixtures were Loose and/or has a gap.
SUGGESTION: Repair or replacement is recommended to restore the lights.
This was observed on the Left Side.

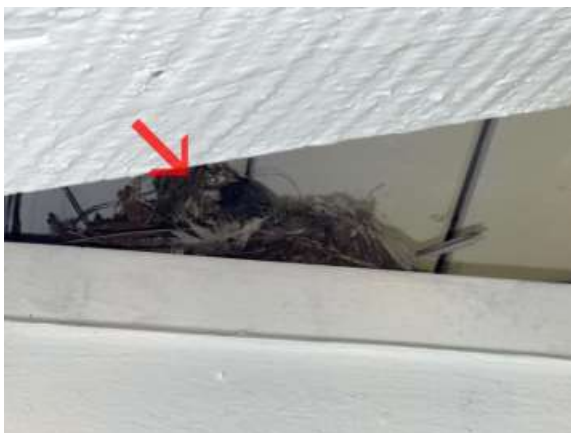
3.29 Bees and Birds

Bird nest(s) were observed on one or more sides of the dwelling.
SUGGESTION: We recommend any entry points be properly covered and the nest be removed.

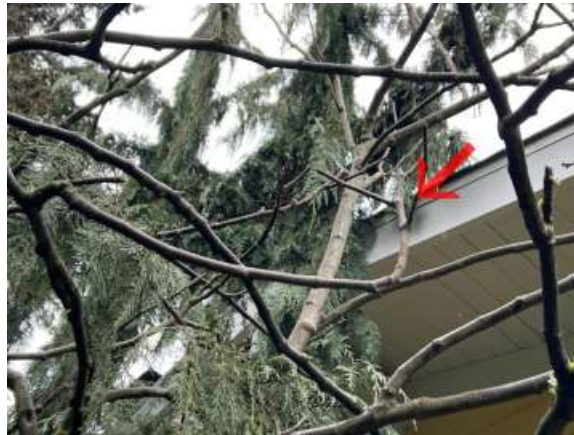
Tree limbs or branches were touching the dwelling on one or more sides. This situation can lead to costly damage to the structure if not mitigated or controlled, especially during high winds or a path for rodents, animals and pests.

SUGGESTION: We advise that all tree limbs or branches be removed for the touching the building.

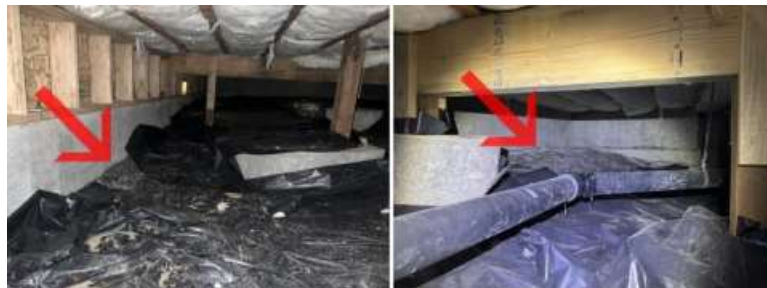
- 4.6 *Vapor Information* An adequate vapor barrier will create a dry air space between the damp soil and the framing, which will limit the amount of moisture that is able to rise into the framing. This also reduces the possibility of future moisture damage which will also help keep the moisture content of the soil at an equilibrium. The preferred material for use as a vapor barrier over soil in the Crawl Space is 6 mil., or thicker, polyethylene often referred to as "visqueen".
- 4.7 *Condition* Partial coverage of the soil by a vapor barrier was observed at various areas.
SUGGESTION: We recommend completion of the vapor barrier where necessary to cover all of the exposed soil.

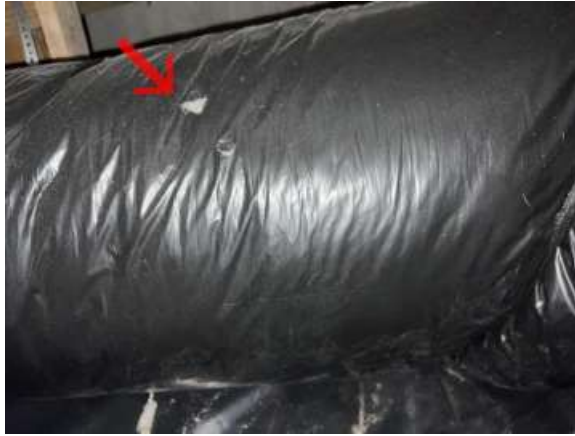
- 4.8 *Insulation* Several areas of the plastic that covers the duct insulation are torn. This may allow air to seep out and into the Crawl Space area.
SUGGESTION: We advise tapping and sealing all small tears in the plastic around the ducts to prevent heat loss.

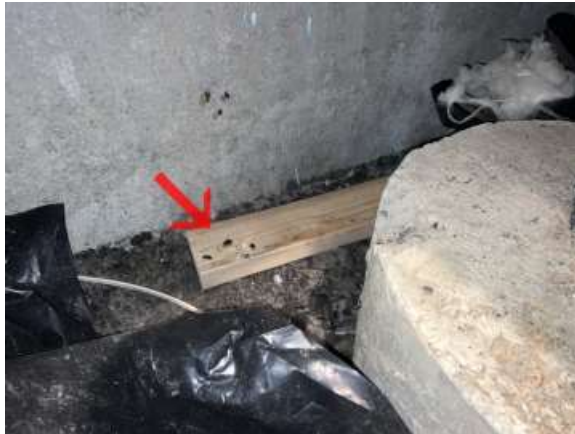
4.9

The codes are-- IRC-408.4, UBC-1906.2.1.

SUGGESTION: Removal of all wood or other material containing cellulose in direct contact with the soil is recommended, to reduce a condition conducive to infestation by wood destroying organisms.

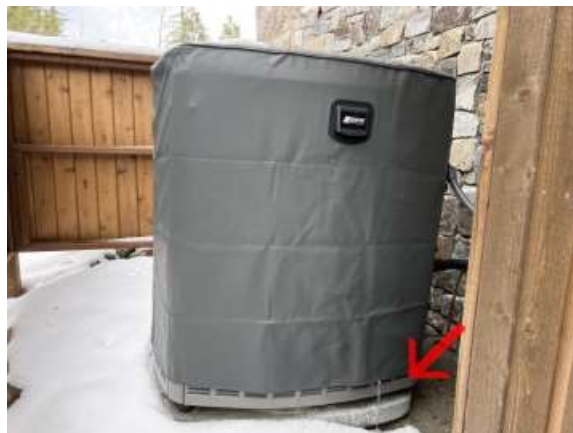
5.8

The supporting pad for the exterior condensing unit was not level. The connections can be stressed and accelerated wear on components may occur. **SUGGESTION:** A qualified contractor should evaluate this condition and determine what corrective measures can be taken.

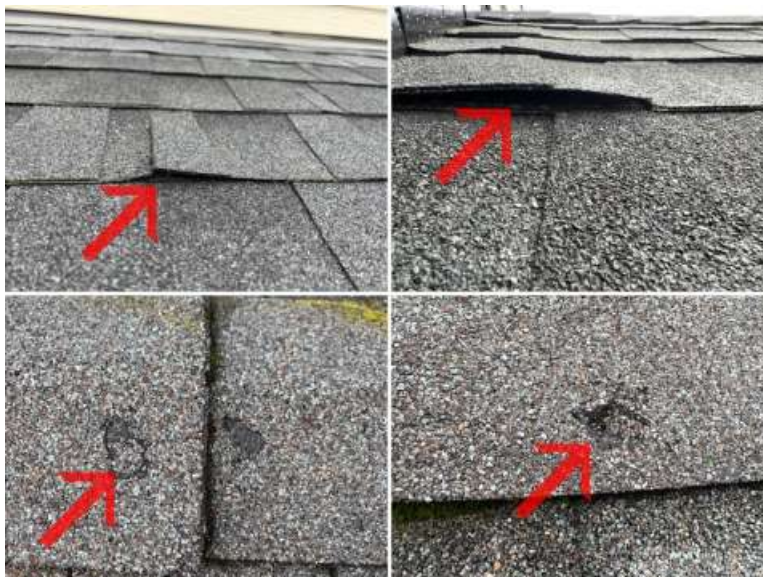
| | The roof surface has torn shingles.

<i>SUGGESTION:</i> It is recommended that any torn shingles be replaced as necessary to prevent further possible damage to the adjacent areas or future leakage.
This was observed in several sections. |

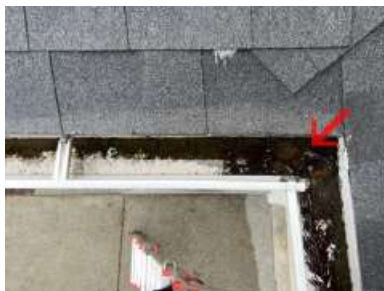
The condition of the gutters may change after the debris and water is removed.

SUGGESTION: The gutters should be kept clear to reduce the potential for back-ups and subsequent water penetration of the structure, which can result in damage to exterior and interior elements.

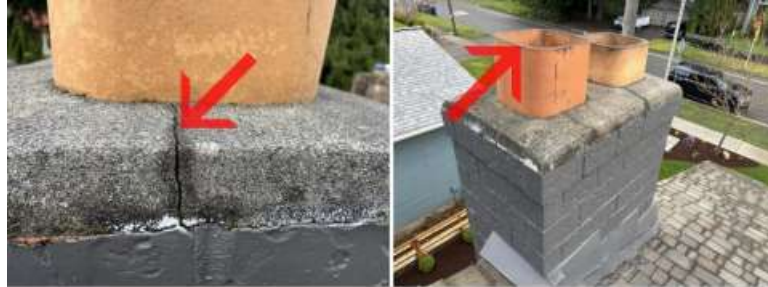
The metal chimney flue did not include a spark arrester/rain cap and it appears to have been removed or blown off the flue during a wind storm.
SUGGESTION: We recommend that it be reinstalled as required. This will help keep out rain water and birds which may damage or clog the chimney flue or damper.

The chimneys mortar cap showed signs of minor deterioration.
SUGGESTION: The cap should be repaired during routine property maintenance.

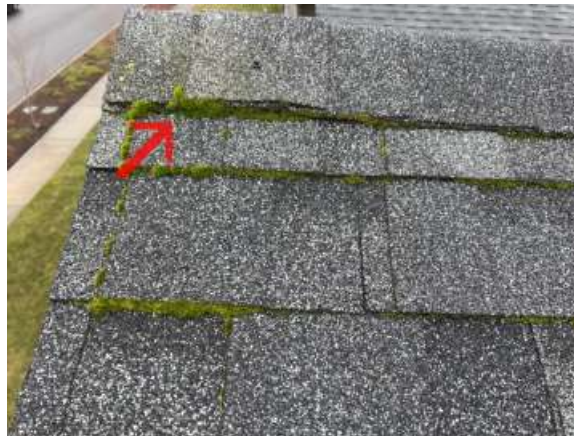
Moss, lichen and/or debris from trees was observed on the roof surface. This will restrict drainage off the roof and into the gutters/downspouts.
SUGGESTION: Debris and moss on the roof should be cleaned and/or removed to reduce the potential for damage to the roofing materials.

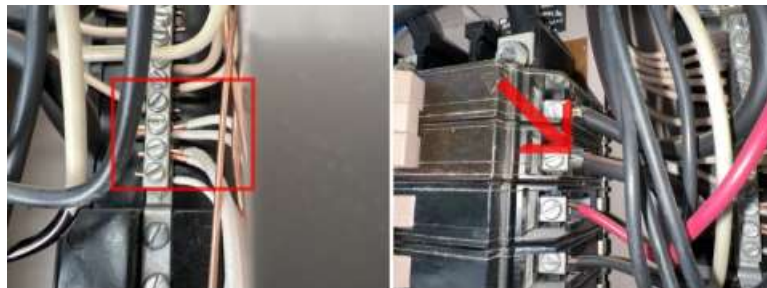
- 9.10 Panel Wiring Conditions Multiple neutral wires (white) are attached to the same terminal on the buss bar. The neutrals (white) need to be on their own terminal.
SUGGESTION: We recommend correction of this condition.

There is no antioxidant installed on the aluminum wiring.
SUGGESTION: It is recommend that the paste be installed.

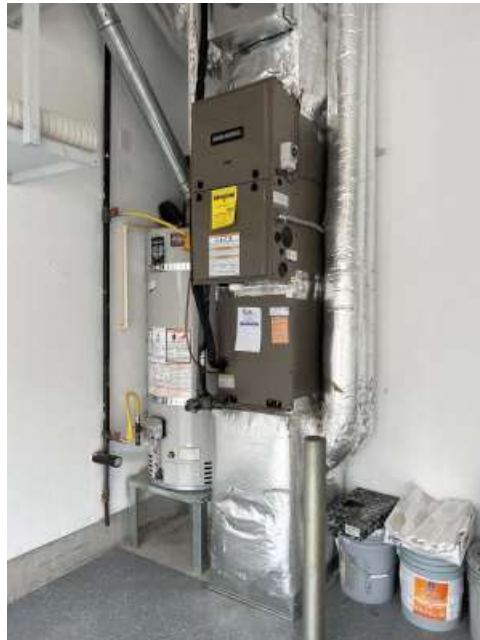
10.1 Type

The heating type for this dwelling was a forced air furnace.

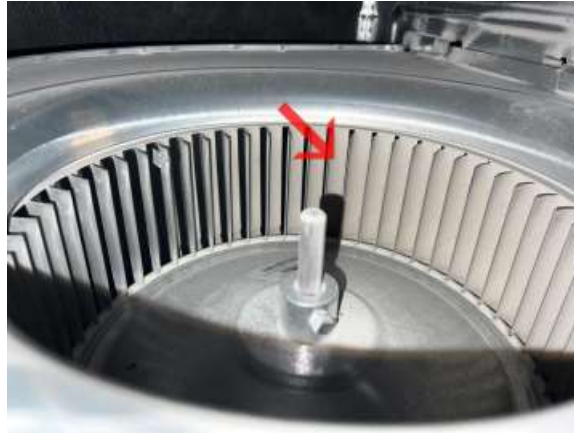
10.8

Dust and/or debris have built up on the blower and in the blower compartment. **SUGGESTION:** We recommend the blower and its compartment be cleaned. The blower's bearings should be lubricated as necessary.

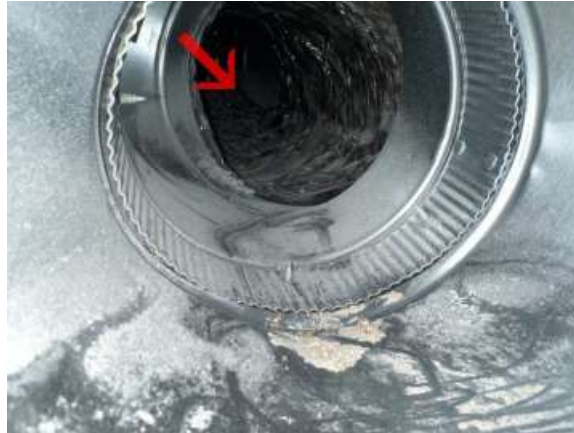
The supply air ducts were dirty.

SUGGESTION: We recommend cleaning the ductwork.

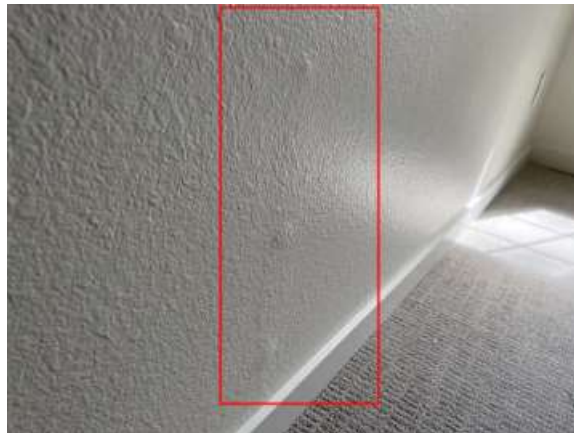
- 12.8 Cracks or nail pops in the drywall were observed. This is due to seasonal movement of the structure caused by changes in humidity and/or minor settlement.
SUGGESTION: We advise monitoring and patching or repair as needed to restore the appearances.

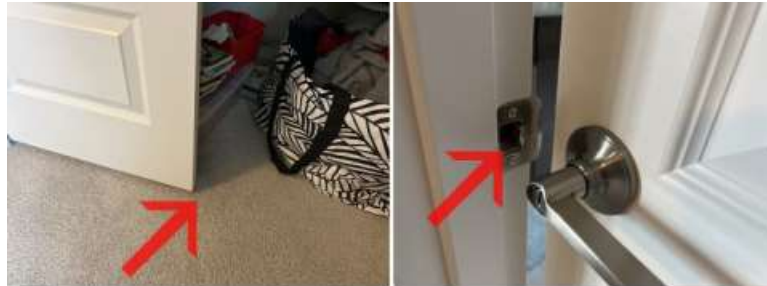
Several of the door's hardware is loose, missing or in need of adjusting to restore its proper operation.

SUGGESTION: We recommend repairs be made.

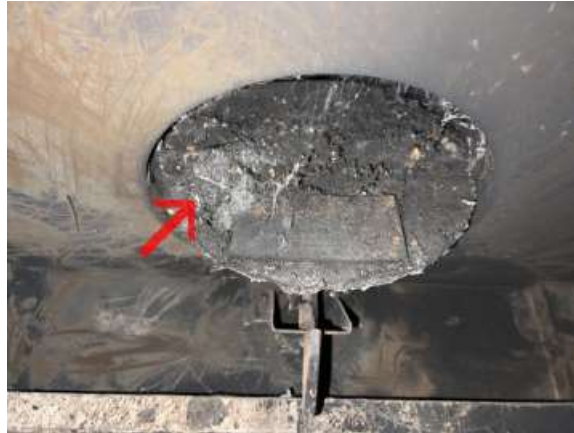
The flue and/or firebox had a heavy built-up of creosote. This limited the evaluation of the interior fireplace.

SUGGESTION: Cleaning and evaluating is recommended.

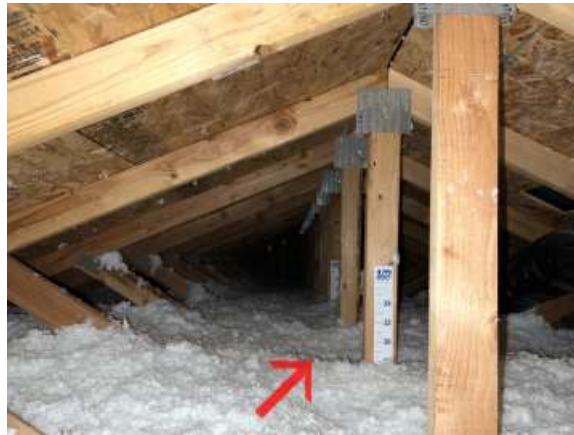
- 13.12 *Condition* The insulation in the Attic was compressed by either stored personal items or people that have entered this area in past. Compressing the insulation is not recommended and it diminishes the insulating "R-factor" when compressed.
SUGGESTION: We advise that the insulation be fluffed or added to restore it's "R" value where necessary.

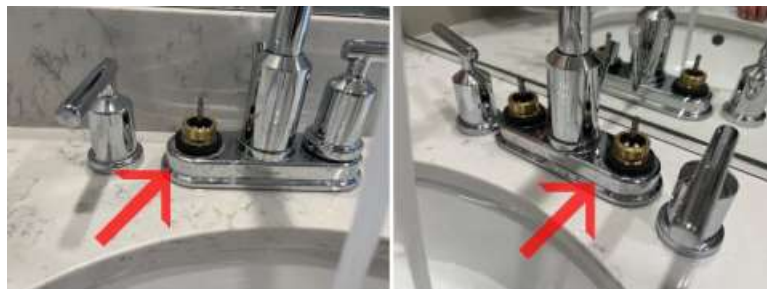
14.4 Wash Basin Handles

The faucet handles on the wash basins were loose. **SUGGESTION:** We recommend re-securing the faucet handles. This was observed at Several of the Bathrooms.

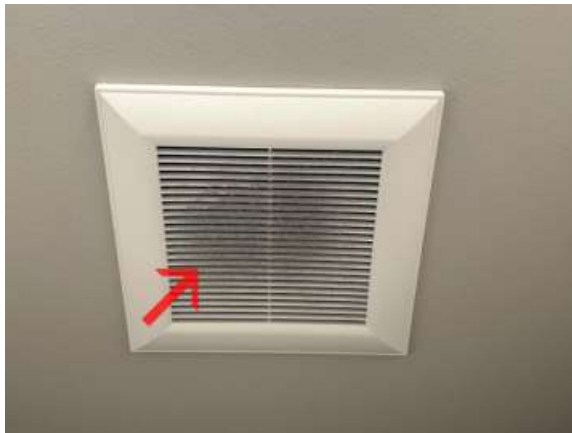
This condition was observed in Several of the Bathrooms.

SUGGESTION: The fan should be cleaned to restore proper operation.

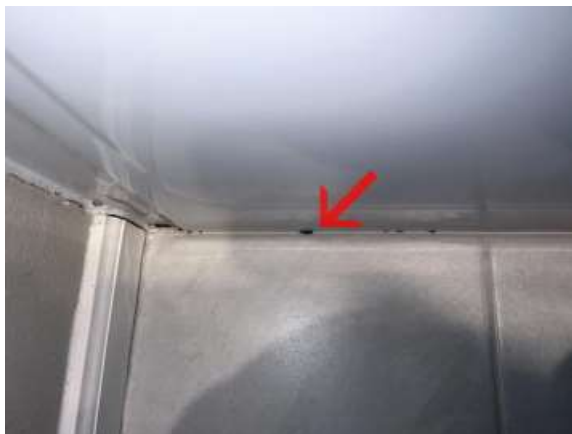
14.10 Caulking Deteriorated and Mildew

This condition was observed in the Master Bathroom.

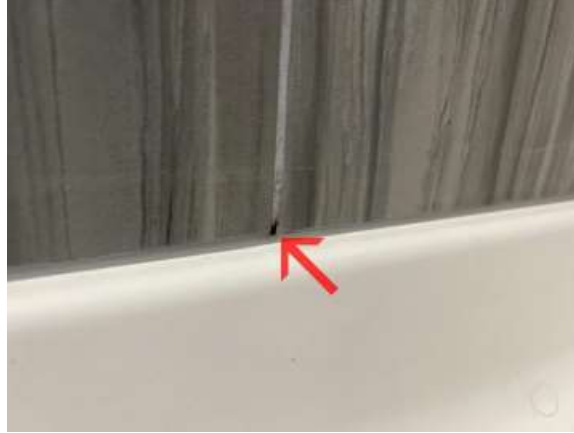
14.11 Conditions

This condition was observed in the Master Bathroom.

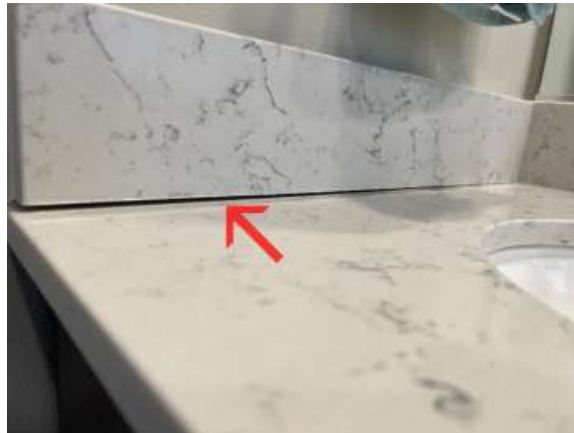
14.12 Backsplash Caulk and Grout

This was observed in the Master Bathroom.

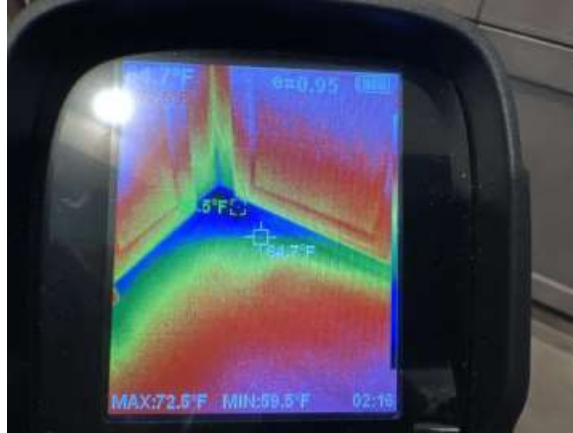
There is an air draft coming from under the Kitchen cabinets.

SUGGESTION: We recommend further investigation to locate and remedy the draft.

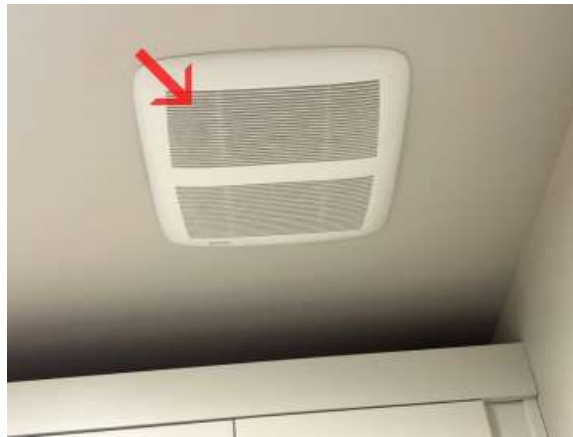
The Laundry Room ventilation was provided by a exhaust fan. The fan was operating and found to be working in an acceptable manner, but the fan is covered with dust or lint. *SUGGESTION:* We suggest that it be cleaned as necessary to help improve exhausting to the Exterior.
