April 22, 2023

RE: 123 Main St.
Small Town, WA.

SUMMARY REPORT

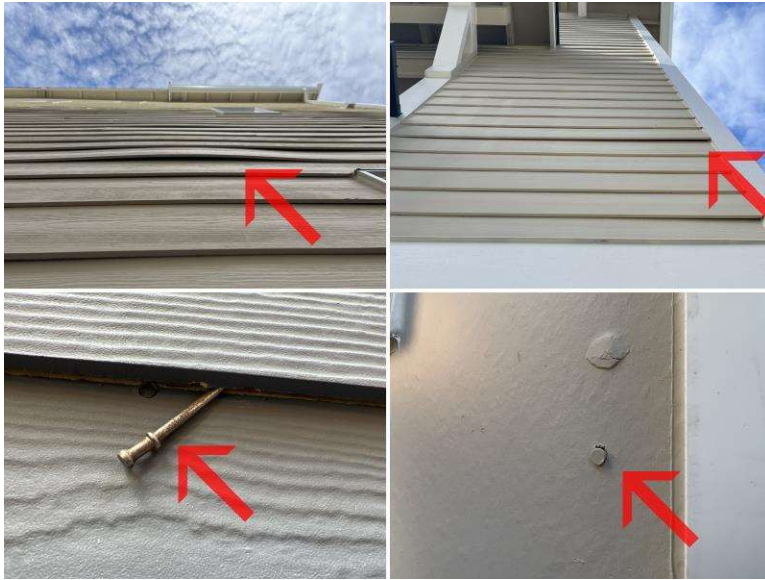
3.6 Condition Damage

1. Nails were sticking out of the siding material. This can cause accelerated deterioration of the siding from moisture.

Small sections of the siding have no space between the planks. This is causing buckling of the siding.

This was observed on the Several Sides.

SUGGESTION: Secure all nails, caulking and painting of all nail heads, surface breaks and depressions that have broken through the siding surfaces is recommended.

SUGGESTION: We recommend repair by the contractor to industry standards.

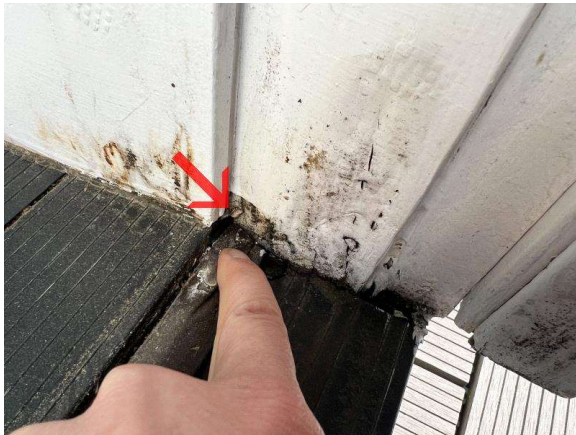
3.10 Damaged, Gaps and Frames

2. The Exterior door frame is damaged.

This was observed at the Rear Door.

SUGGESTION: We recommend that it be repaired or replaced as needed.

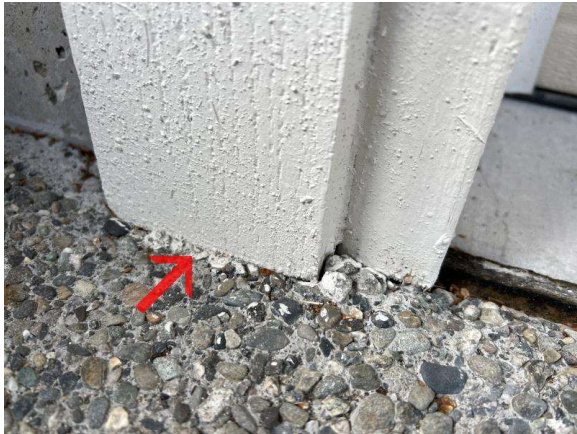
3.14 Trim-Pillars, Concrete, Roof or Loose

3. Portions of the trim are embedded in concrete surfaces. This is not an acceptable practice. Modification would be difficult, but this can allow moisture absorption and pest infestations.

This was observed at the Left Side.

SUGGESTION: We recommend as preventive maintenance the area be flooded with a wood preservative from time to time and that the open seam be caulked or sealed closed to help deny moisture entry.

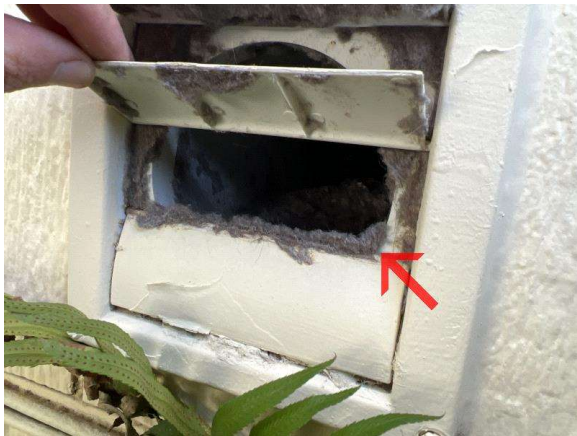
3.24 Clothes Dryer Vent

4. The clothes dryer vent damper had become clogged with lint, dirt or debris. This is a fire hazard and reduces efficiency.

SUGGESTION: Dryer ducts should be disassembled and cleaned on a regular basis.

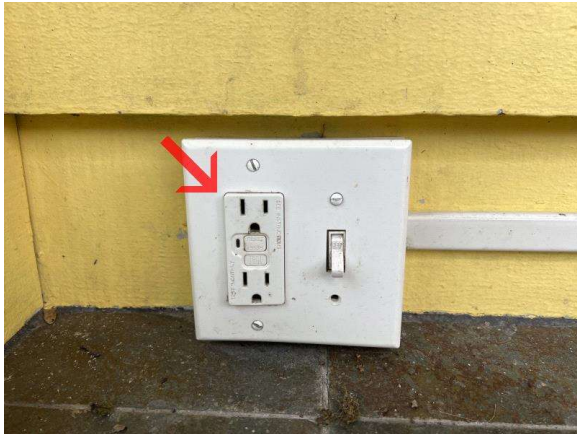
3.27 Receptacles

5. One or more of the Exterior receptacles were missing/damaged their moisture rated cover plates.

This condition was observed on the Rear Side.

SUGGESTION: Proper replacement is recommended.

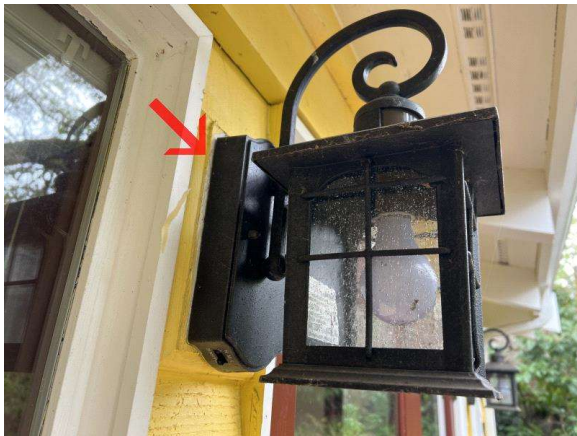
3.28 Light Fixtures

6. Exterior light fixtures were Loose and/or has a gap.

This was observed on the Left Side.

SUGGESTION: Repair or replacement is recommended to restore the lights.

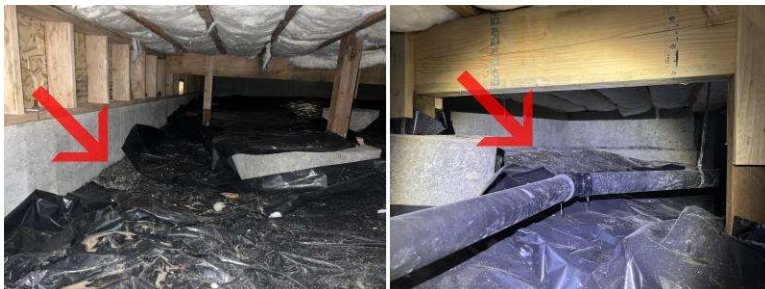
4.7 Condition

7. Partial coverage of the soil by a vapor barrier was observed at various areas.

SUGGESTION: We recommend completion of the vapor barrier where necessary to cover all of the exposed soil.

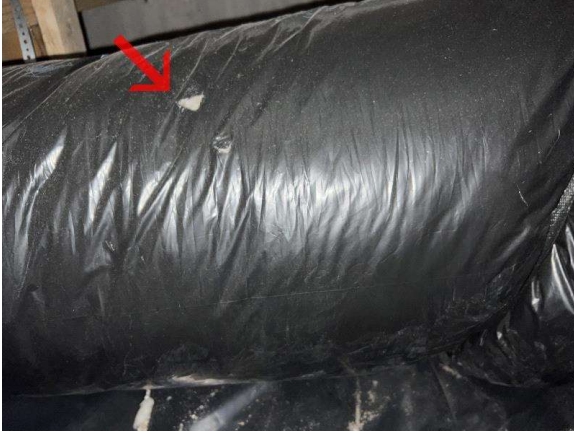
4.8 Insulation

8. Several areas of the plastic that covers the duct insulation are torn. This may allow air to seep out and into the Crawl Space area.

SUGGESTION: We advise taping and sealing all small tears in the plastic around the ducts to prevent heat loss.

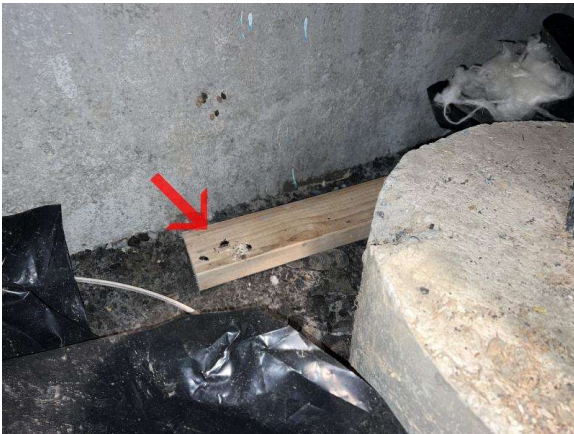
4.9

9. Form-wood, cardboard on the ground or around the piers and/or scrap wood was left on the soil or at the base of the foundation in the Crawl Space. Cellulose debris can easily harbor wood destroying organisms.

The codes are-- IRC-408.4, UBC-1906.2.1.

SUGGESTION: Removal of all wood or other material containing cellulose in direct contact with the soil is recommended, to reduce a condition conducive to infestation by wood destroying organisms.

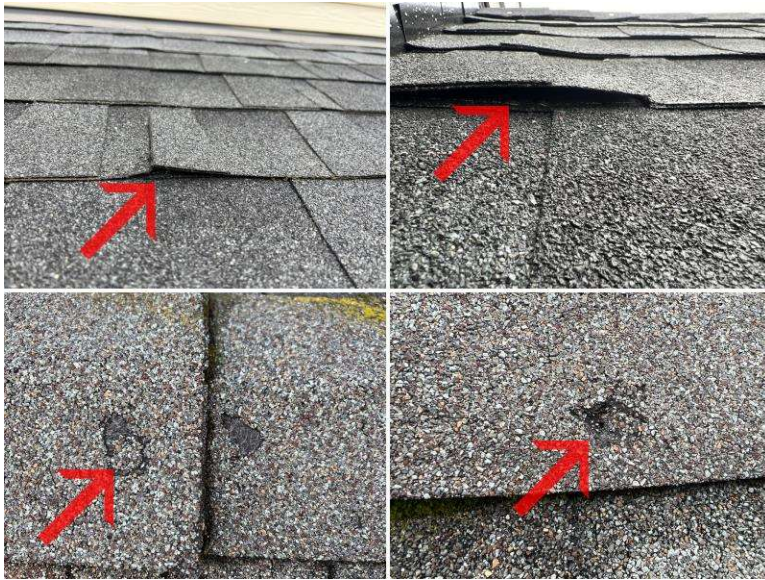
7.10 Condition

11. Several buckled shingles were evident on the roof surface.

The roof surface has torn shingles.

This was observed in several sections.

SUGGESTION: The buckled shingles should be replaced or repaired.

SUGGESTION: It is recommended that any torn shingles be replaced as necessary to prevent further possible damage to the adjacent areas or future leakage.

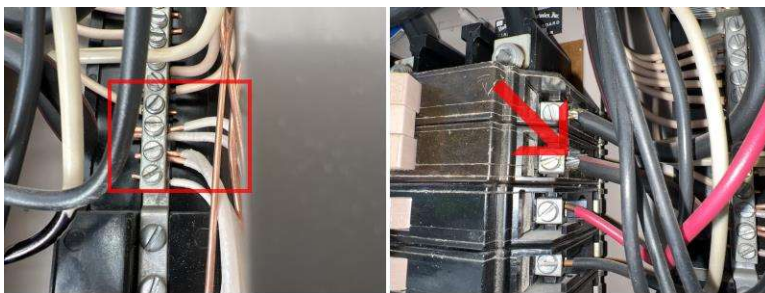
9.10 Panel Wiring Conditions

12. Multiple neutral wires (white) are attached to the same terminal on the buss bar. The neutrals (white) need to be on their own terminal.

There is no antioxidant installed on the aluminum wiring.

SUGGESTION: We recommend correction of this condition.

SUGGESTION: It is recommend that the paste be installed.

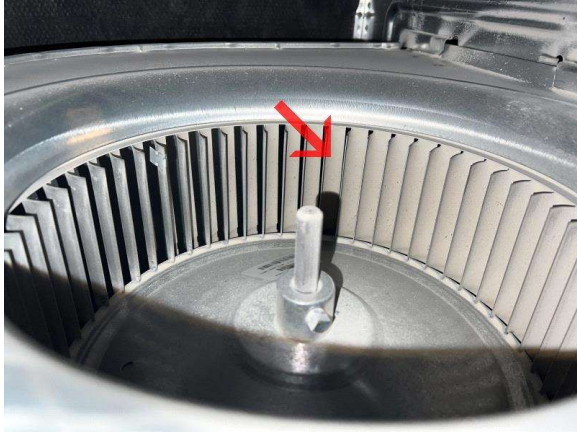
10.8

13. Dust and/or debris have built up on the blower and in the blower compartment.

SUGGESTION: We recommend the blower and its compartment be cleaned. The blower's bearings should be lubricated as necessary.

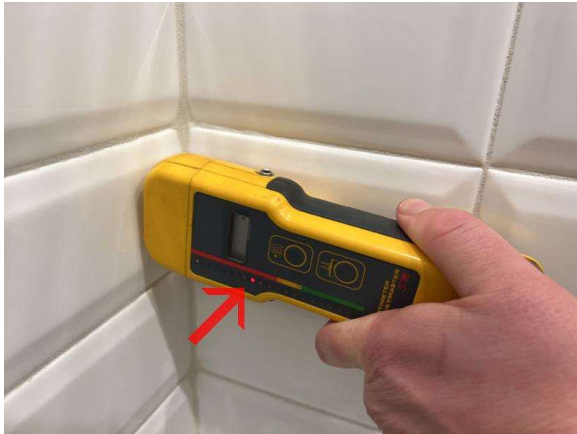
14.8

16. Moisture was noted behind the shower wall(s) on a meter above 30%. The maximum acceptable percentage is 17%.

SUGGESTION: A contractor should further evaluate and repairs are recommended. This condition was observed in the Master Bathroom.

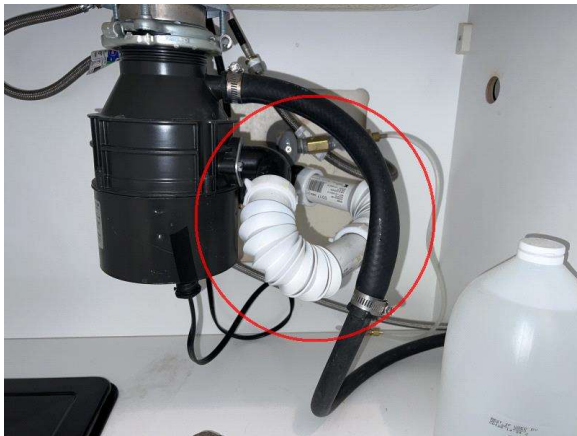
15.4 Drains and Traps

17. The drain pipe under the sink was flexible rubber or plastic, which is non-conforming and can clog.
SUGGESTION: The system was functional and modifications would be considered optional.

The drain line for the sink lacks adequate pitch from the "P" trap to the wall. This configuration can promote clogging.

There was no drain trap installed under the sink. The trap prevents sewer gasses from backing up into the dwelling. The lack of a trap is a significant defect and a health hazard.

SUGGESTION: We advise adjustments be made to give the line a constant downhill slope of at least 1/4" per foot for optimal function of the sewer system.

SUGGESTION: We recommend the installation of a proper trap system in accordance with industry standards.

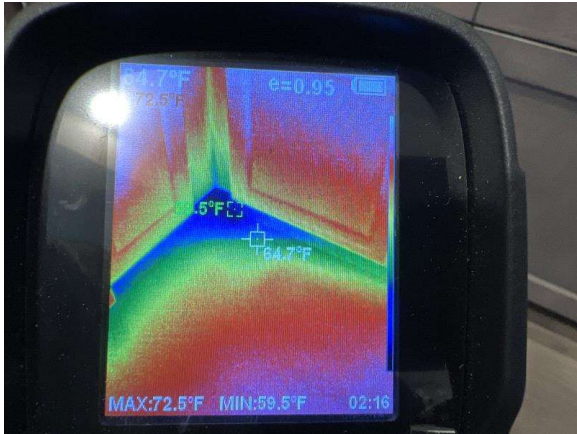
15.9

18. There is an air draft coming from under the Kitchen cabinets.

SUGGESTION: We recommend further investigation to locate and remedy the draft.

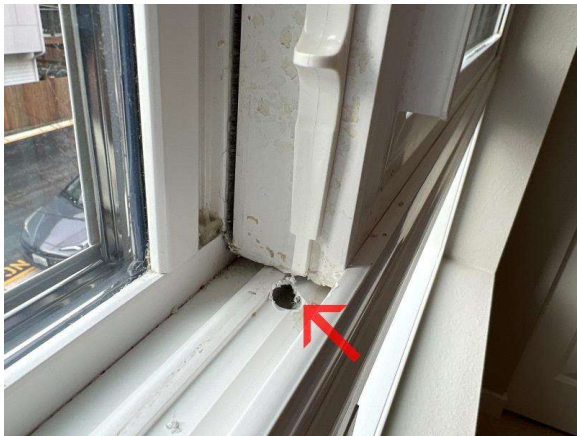
17.5 Windows

19. The locking mechanism and frame for one window in this room is in need of repair.

SUGGESTION: We recommend the window not be used until repairs are completed to prevent it from becoming stuck opened or jammed.
