# INFORMATION NOTES

The dwelling was reported to be (36) years old.

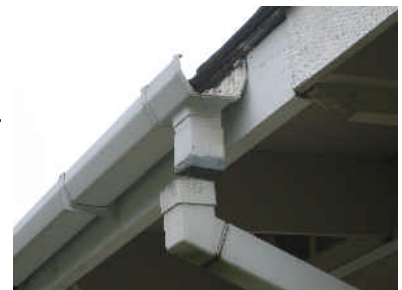
The downspout(s) section(s) were detached.  
*SUGGESTION:* The downspouts section(s) should be secured to restore normal function.  
This condition was observed on the Front Side.

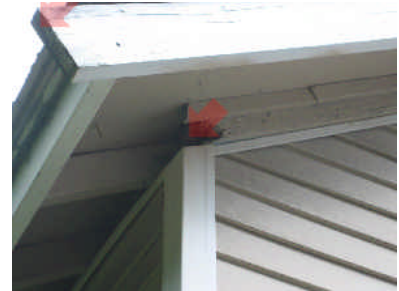
Some sections of the fascia boards were damaged.  
*SUGGESTION:* All fascia boards should be repaired or replaced to restore it to their proper function.  
This condition was observed on Several sides of the dwelling.

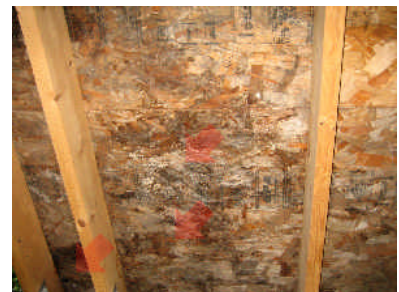
The patio is part of an extension of the roofing material.  
One or more of the panels in the patio were damaged to where replacement would be the most practical course of action.

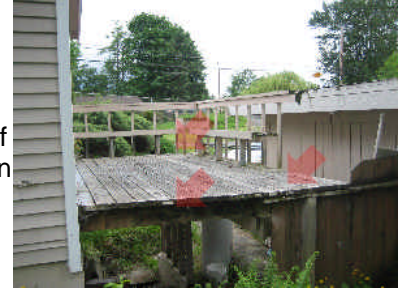
Deteriorated, rotted and/or insect damaged deck boards were observed throughout the deck.

This was observed on the Front Side.

*SUGGESTION:* Replacement of all damaged board materials is recommended. The extent of damage to the deck members will not be known until repairs are in progress.

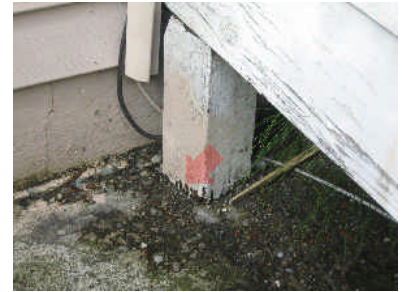
Sections of the support posts for the deck are rot damaged, affecting the dependability of the deck/roof supports.

This was observed at the Rear Side.

*SUGGESTION:* Replacement is recommended where necessary. A thorough inspection of all supports should be performed and replaced as necessary.

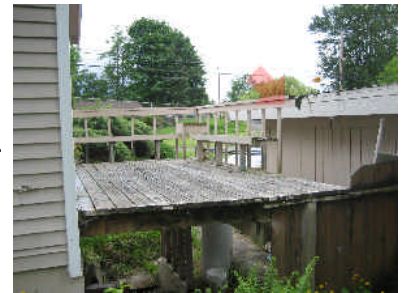
This condition was observed on the Front Side.

*SUGGESTION:* Railings should be installed with normal industry trade practices to reduce the potential for personal injury.

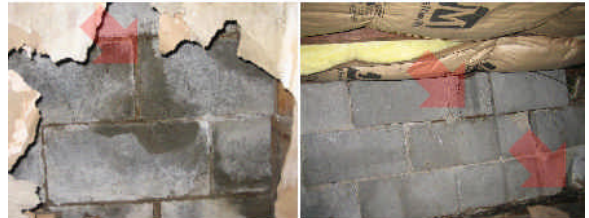
Major rotation and/or damage of the foundation was observed. This is common in an older foundation of this design. We observed related conditions suggesting the need for immediate repairs.  
*SUGGESTION:* We recommend a contractor evaluate the condition and determine repairs.

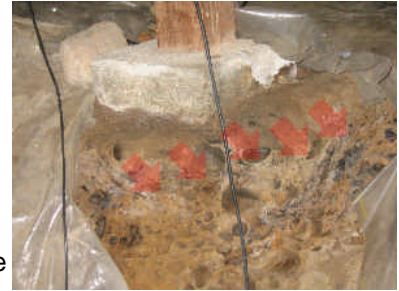
The foundation pier(s) has been undermined in one or more sections.

This was observed on the Front Left Side of the foundation.

*SUGGESTION:* All sections of the structure foundation which are undermined should be backfilled with approved material by a contractor. Generally, the soil under a pier should not be cut or excavated back more than 45 degrees.

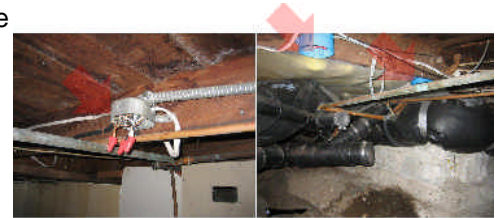
Several uncovered junction boxes were observed in multiple areas.

*SUGGESTION:* The open junction boxes should be enclosed with an approved cover plates to comply with industry standards.

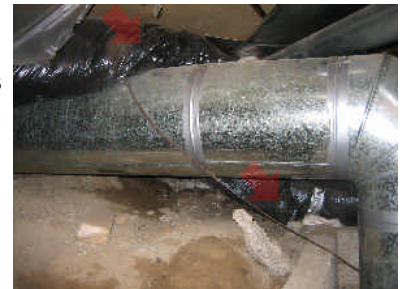
One or more of the ducts were damaged or crushed.

*SUGGESTION:* All damaged ducts or sections should be repaired or replaced as necessary.

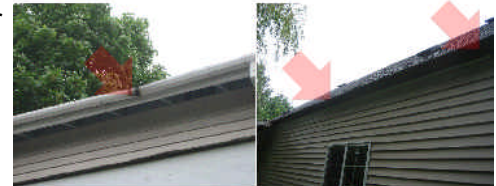
Sections of the gutters were damaged.  
*SUGGESTION:* All damaged, rusted or rotted gutters should be repaired or replaced in accordance with industry standards.  
 This was observed on Several Sides.

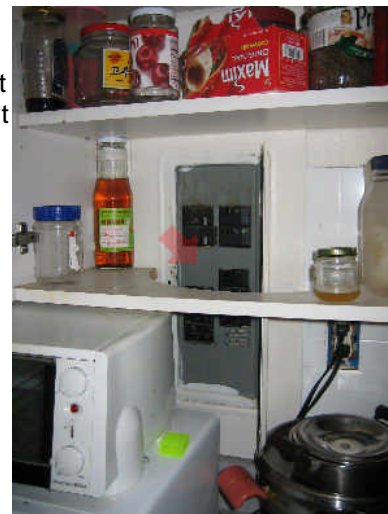
The main service panel was inaccessible and was not inspected.

*SUGGESTION:* Industry standards require that an un-obstructed clear area be provided in front of the electrical panel.

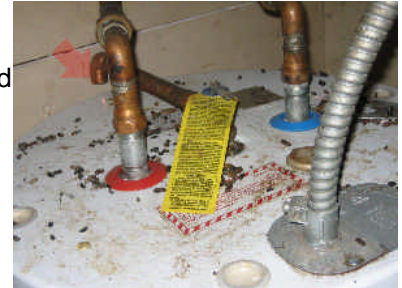
The discharge pipe for the temperature and pressure relief valve was too short.  
*SUGGESTION:* For safety, the temperature and relief valve discharge pipe should terminate within 6" of the grade (ground).

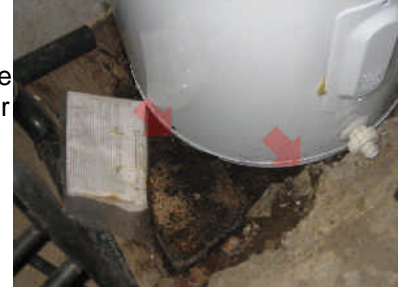
The water heater is installed directly on the concrete floor.

*SUGGESTION:* We recommend that the unit be drained and a Styrofoam pad be installed under the tank to help prevent moisture deterioration at the bottom of the tank.

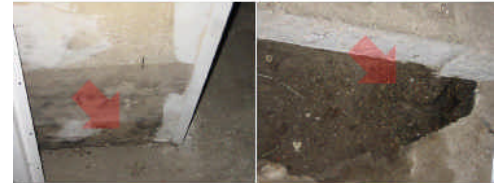
A wall in this room is damaged and mold.

*SUGGESTION:* We advise that all damaged wall sections be repaired to its original condition.

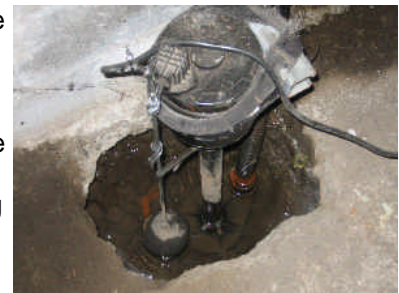
The sump is continuously filling with water. The water flow never ended even after multiple draining. There is a high water table and/or a continuous sub-surface runoff.

*SUGGESTION:* We recommend a specialist be retained to evaluate and determine a course of correction. The water flow condition is affecting the foundation.
