Inspection reference: Sample

Confidential Inspection Report
123 Main St.
Small Town WA

April 22, 2023

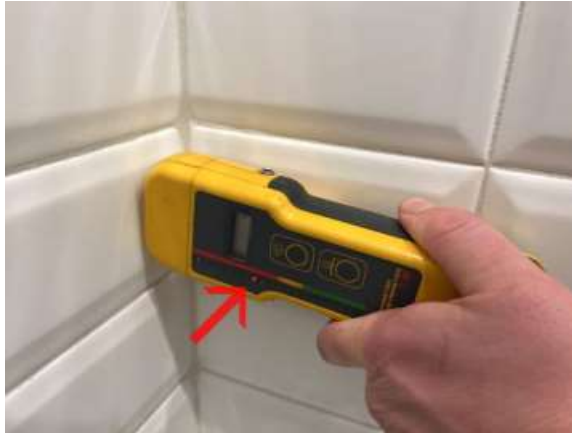
Moisture was noted behind the shower wall(s) on a meter above 30%. The maximum acceptable percentage is 17%. **SUGGESTION:** A contractor should further evaluate and repairs are recommended. This condition was observed in the Master Bathroom.
